# Manhole Inspection Summary

Manhole # S06AA2016MH

Insp Date: **10/23/06 10:38 AM**

**Location** Address: **3829 LABYRINTH RD**

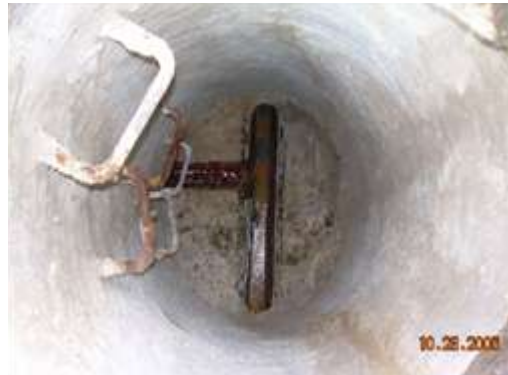
Top View

Corroded steps. Bench debris.

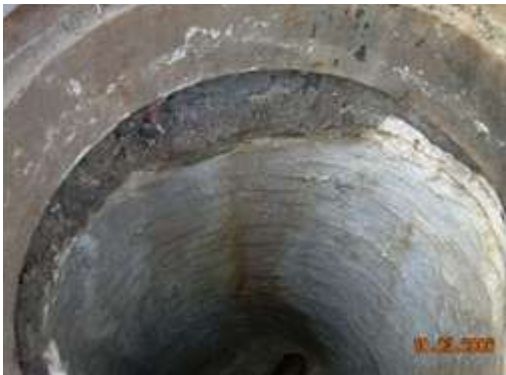
Defect

Frame leaks. Adjustment deterioration and loose brick. Adjustment and Barrel infiltration.

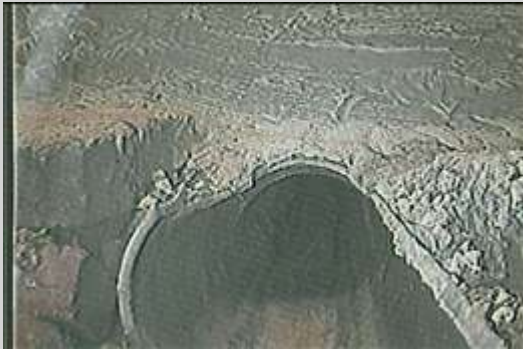
### 8 in. Circular Gravity Sewer Pipe Out @ 12 O'Clock

Comments **The O12 pipe picture shows Channel deterioration.**

Infiltration: **Evidence** Pipe Seal Cond: **Unknown**

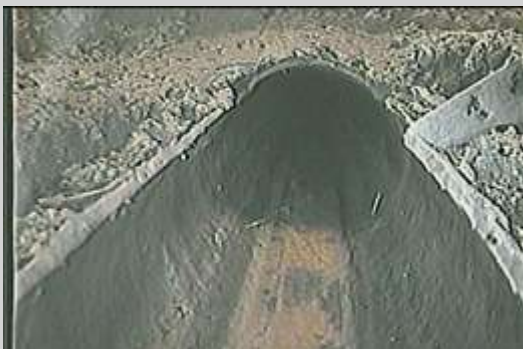
### 8 in. Circular Gravity Sewer Pipe In @ 6 O'Clock

Infiltration: **Evidence** Pipe Seal Cond: **Unknown**

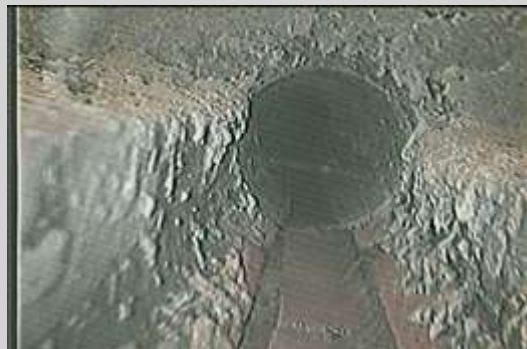
Pipe In @ 9 O'Clock

Infiltration: **Evidence**
